FINAL REPORT
JANUARY 1998

REPORT NO. 96-03

BULLPUP
CHEMICAL OVERPACK
CONTAINER EVALUATION

VALIDATION ENGINEERING DIVISION
SAVANNA, ILLINOIS 61074-9639

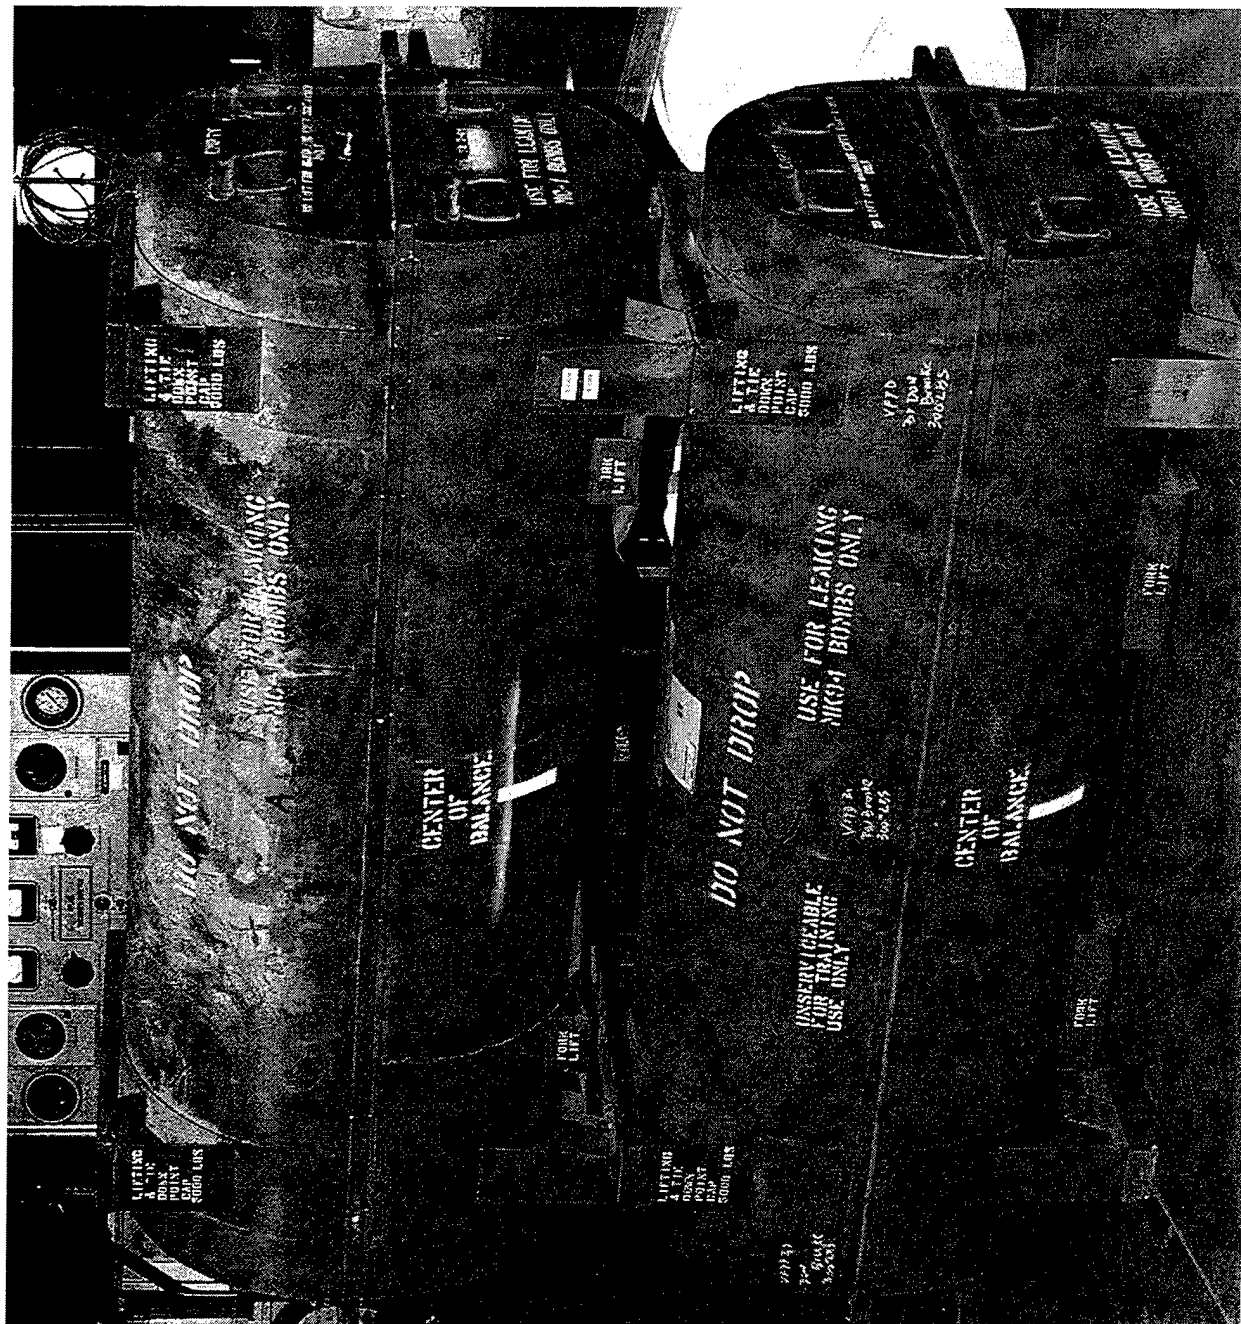
PHOTO NO. A0317-SCN98-DEVOVPK01.TIF. This photo shows an overview of the two BULLPUP containers used in the evaluation.

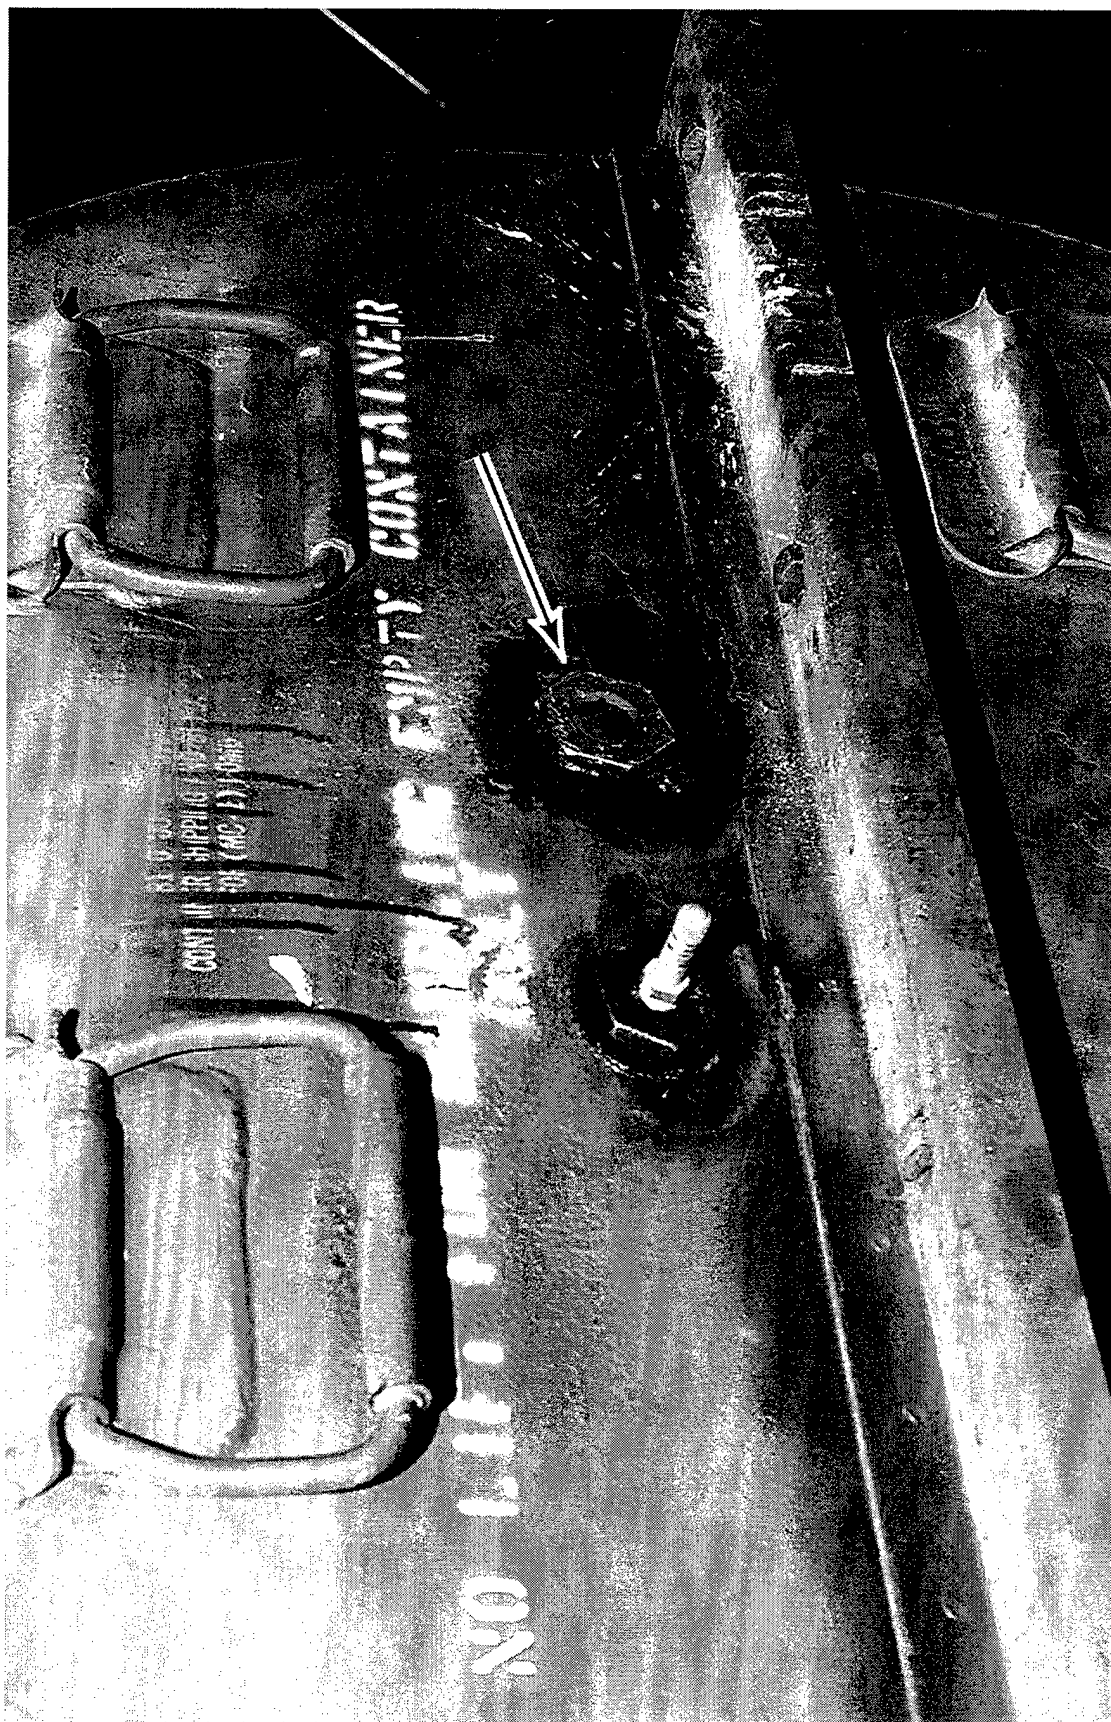
U.S. ARMY DEFENSE AMMUNITION CENTER - SAVANNA, IL	
PHOTO NO. A0317-SCN98-DEVOVPK8.TIF. The arrow indicates the humidity indicator cover. A butyl rubber washer is placed over the threads. Butyl rubber sealant was also placed on the threads prior to installation.

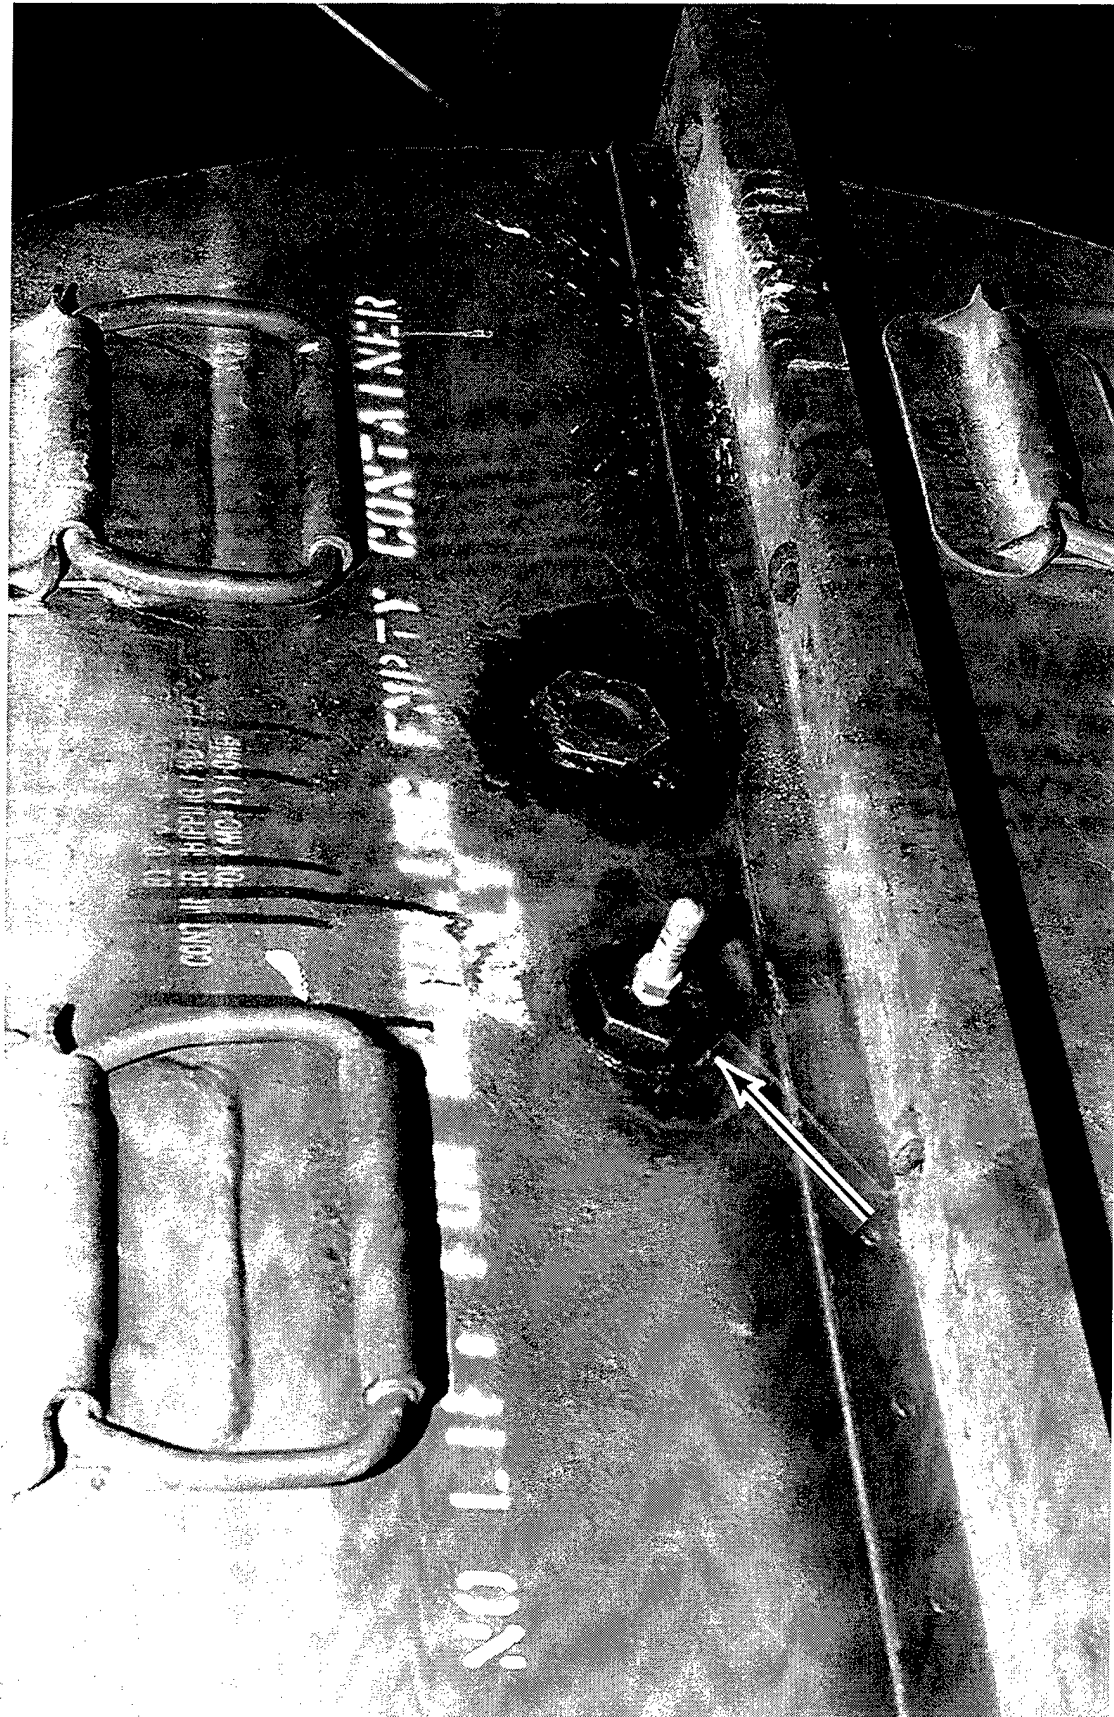
PHOTO NO. A0317-SCN98-DEVOVPK8.TIF. The arrow indicates a threaded plug with a shraeder valve installed. The plug had a butyl rubber washer and butyl rubber sealant placed on it prior to installation. The shraeder valve threads were covered with thread sealant with Teflon prior to installation.

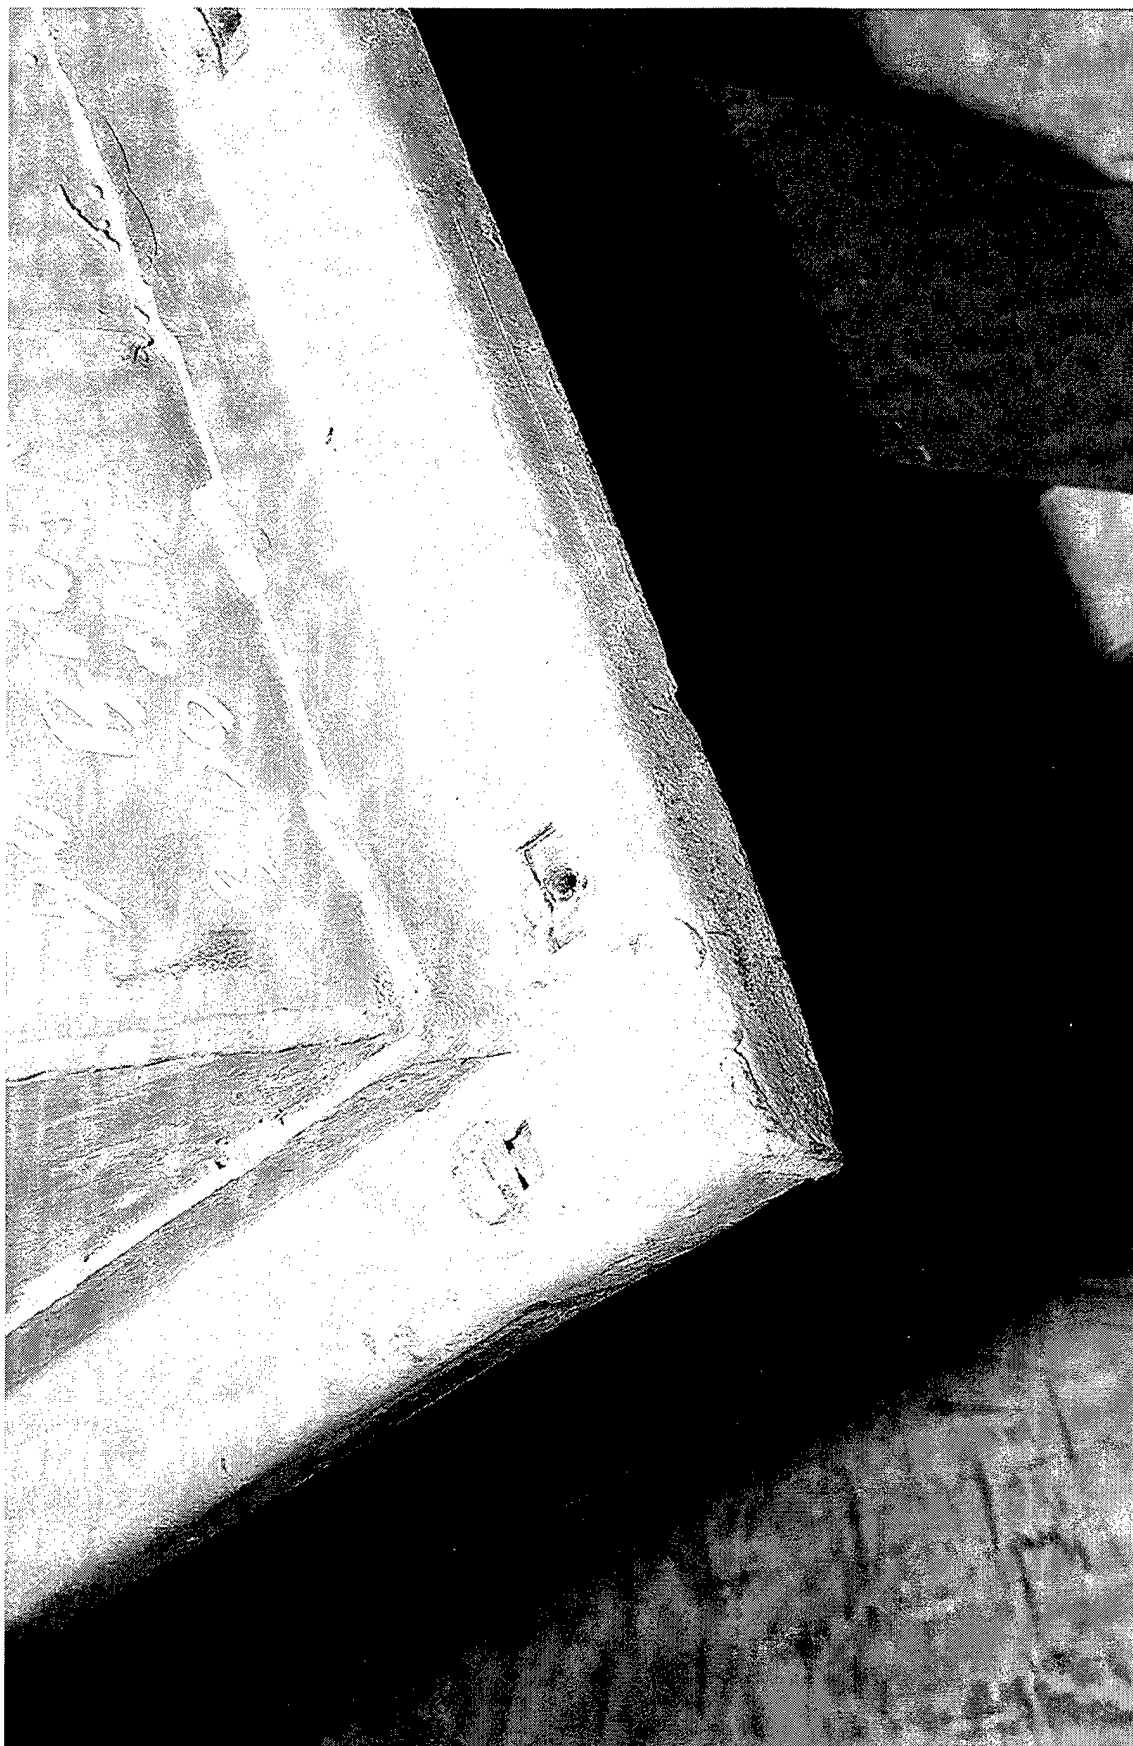
A visual inspection of the two BULLPUP containers was performed prior to testing. Container No. 1 was marked "Serviceable." It appeared to be in generally good condition. Small indentations existed in the flange, apparently caused by excessive torque applied to the Tee-bolts. Container No. 2 was marked "Nonserviceable." The flange had also been damaged, apparently from excessive force applied to the Tee-bolts during previous use.

As previously stated, each BULLPUP container has small indentations in the flange caused by excessive torque applied to Tee-bolts during previous applications. The indentations existing in the flange prior to the testing made it difficult to determine the exact torque that resulted in permanent deformation of the flange. At 200 in-lbs, visual inspection did not identify any permanent deformation to the flange of the containers. A torque of 250 in-lbs appeared to cause minimal permanent deformation of the flange. At 300 in-lbs, permanent indentations occurring in the flange were easily identified.

PHOTO NO. A0317-SCN98-DEVOVPK7.TIF. This photo shows the indentation in the container flange resulting from excessive torque applied to the Tee-bolts.

E. RECOMMENDATIONS. The Tee-bolts currently utilized should be tightened to a torque of 200 +/- 5 in-lbs. The humidity indicator or the breather valve can be replaced by a plug in
